REPORT

of the Committee of Experts formed for the investigation of circumstances related to the transport of equipment for military use on the passenger ferry Estonia in September 1994

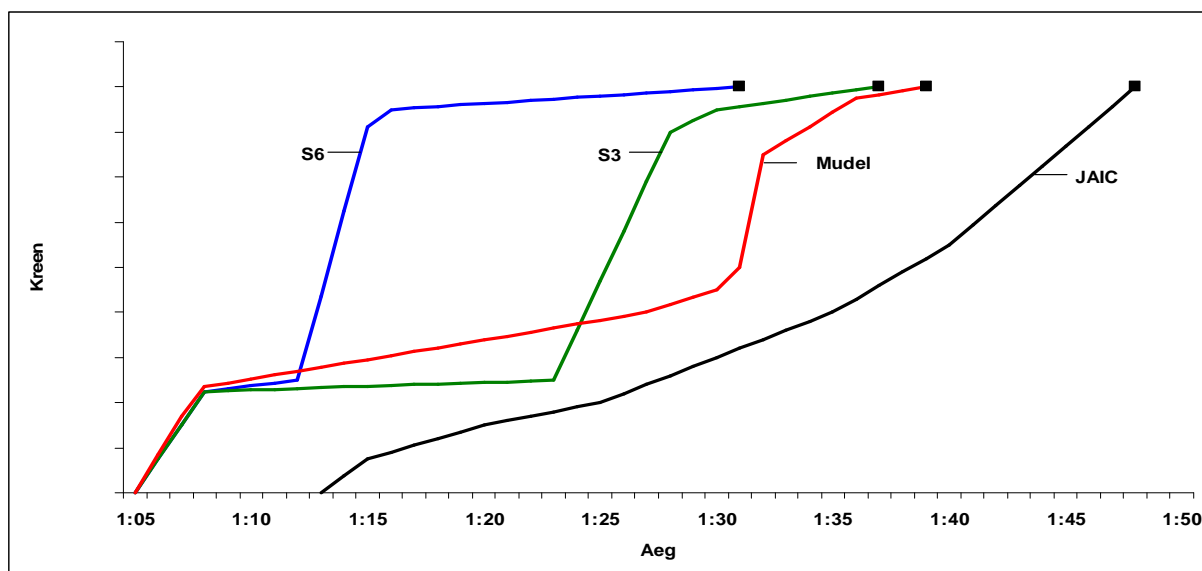
2) The treatment of the JAIC and the consortium of the development of list is also significantly different. According to the Final Report the ship which was moving at full speed developed quickly after opening of the ramp a list of 15° , which remained stable for some time. During this time the speed was lowered, watertight doors were closed and a turn to the left was started. During the turn the list started to increase and it increased further more or less evenly until the sinking of the ship (pages 165 to 167). Model tests carried out by the consortium showed that if the bow ramp is opened on the ship which is moving at a great speed, the list increases evenly and quickly to an angle of 45° . But from then on the list cannot increase evenly. Instead, after the windows break or water enters the deck structure, the ship capsizes in a few minutes. Depending on the strength of windows the capsizing may start sooner or later, but in any case it happens quickly (see section 3.2.6). The differences in the development of the list are shown in the following figure.

[Text in the figure:] List / Time

JAIC (black line) – JAIC version on the basis of the Final Report
 Model (red line) – Model test, where the watertight doors and vehicle deck doors were open

- S3 (green line) – Simulation, where the strength of windows was 10 m and the watertight doors were open
- S6 (blue line) – Simulation, where the strength of windows was 5 m and the watertight doors in the aft were open
- – The moment, when the ship disappeared completely from the water surface
