Final Report- Research Study on the Sinking Sequence of *MV Estonia*

SSPA Consortium

SSPA Research Report No. 134, 2008

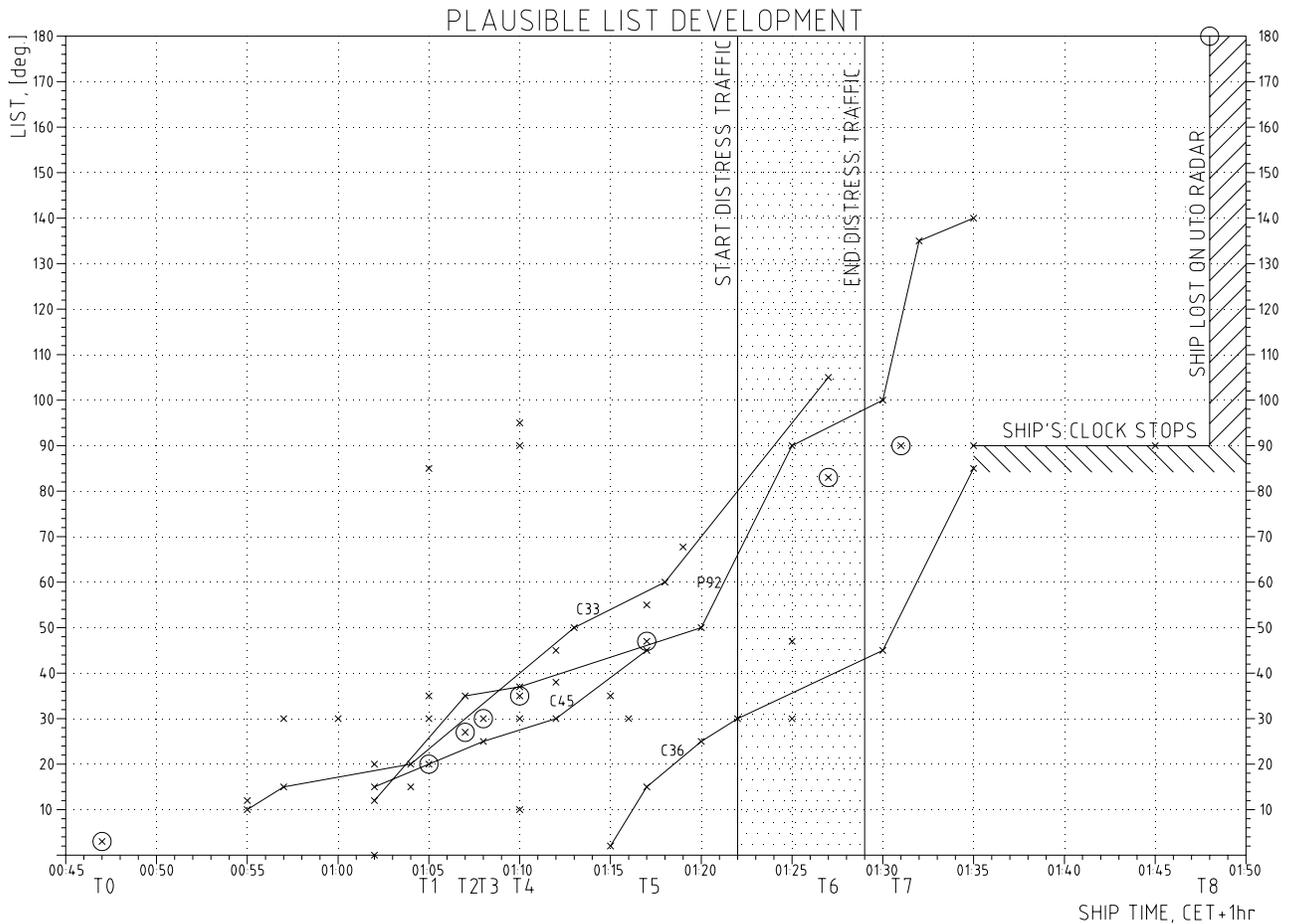
Fig. 3. Plausible list development, from Project Report No. 5.

During the development of the disaster, eventually the bow ramp is closed either by wave impact or by gravity when the list is exceeding 90°, leaving just a small gap. Structural damages on the bottom of the ramp are noted by two survivors, P3 and P34, when they are climbing down the closed ramp at a list exceeding 90°.

A graph of the plausible list development is shown in Fig. 3.

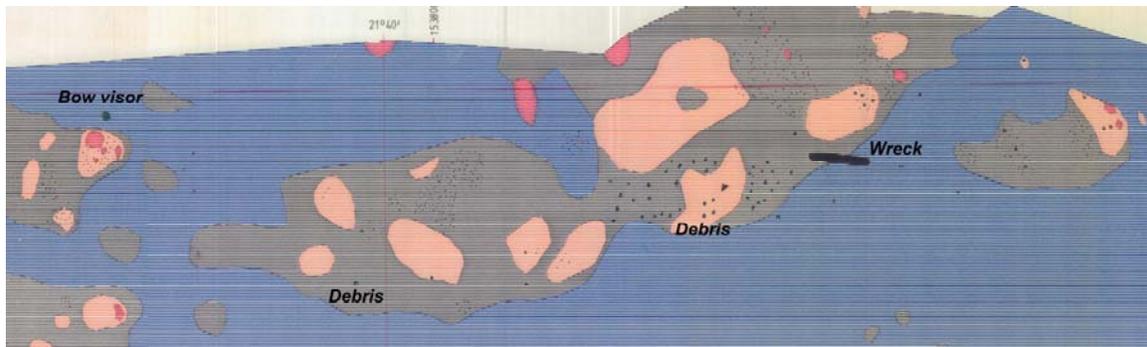
Fig. 23. Sonar plot of seabed. Courtesy of Dr. Nuorteva, Supplement No. 501 of [2]. “Debris” indicates possible lost material from *MV Estonia*.

The ship was, in the simulations, controlled by an autopilot keeping the ship on course before the drop of the visor and providing the port turn after. The roll stabilizing fins were assumed to be active, and port heeling tank was initially filled with water, but was after a certain time emptied (at which time the starboard tank was filled). In each simulation carried out, the ambition has been to pass close to the debris positions indicated in Fig. 23 and in the track plots. The simulations were stopped when the heel angle exceeded 90 deg, with a drifting direction towards the wreck, see also sonar plot in Fig. 23.

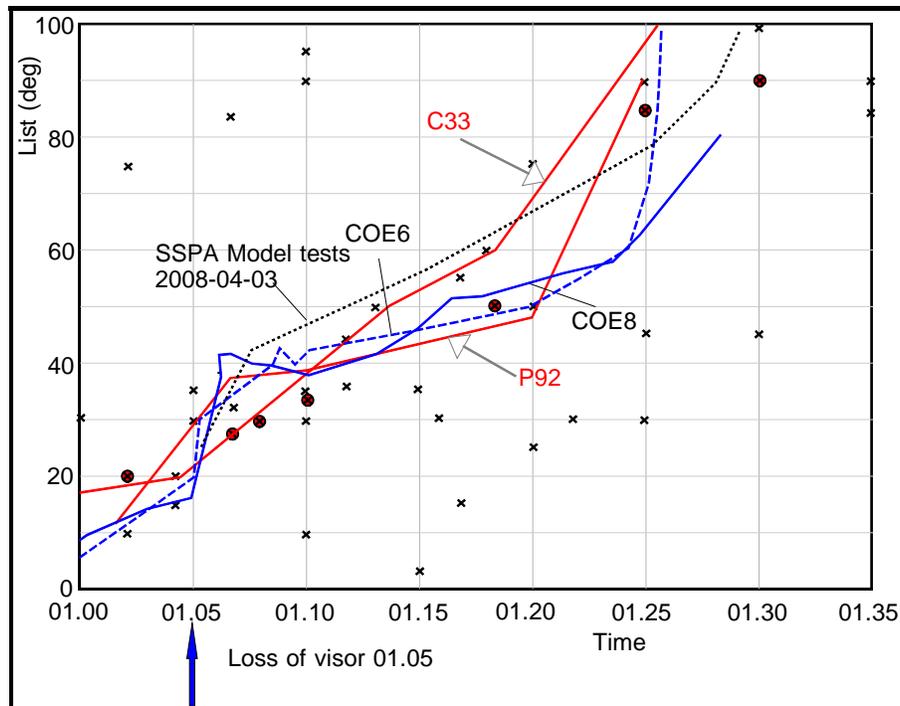
Fig. 27. List development versus time from witness statements C33 and P92 (cf. Fig. 3), SEAMAN simulations (COE6 and COE8), and model test.

The results from the two simulations 6 and 8 (COE6 and COE8 in Project Report No. 11) have been plotted in the diagram of Fig. 27, where the list angle development versus time is shown. In this diagram is also plotted a number of witness statements (cf. Fig. 3) as well as results from model tests of Project Report No. 12. In simulation 8 the initial heading angle was 240 deg instead of 281 deg.

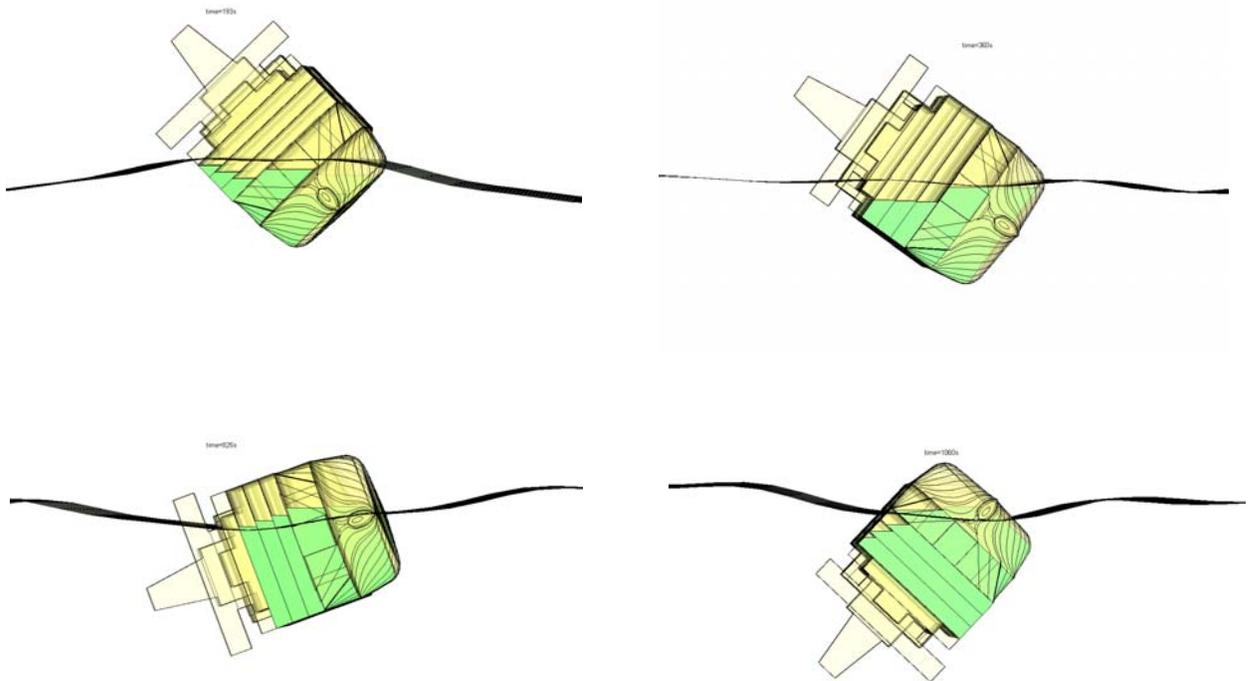
Fig. 31. Snap shots from a final stage simulation with flooded water in green color.

The simulations of the final stage starts with the assumption that the car deck is flooded with 2500 tonnes of water and the ship is drifting at beam seas. In Project Report No. 10 a time series representation of a final stage simulation is shown, where the ship capsizes and finally sinks after 21 minutes.

Fig. 31 shows snapshots from a final stage simulation. Physical mechanisms of importance to the foundering are explained in connection with similar snap shots in Chapter 3.2.1 of Project Report No. 10.

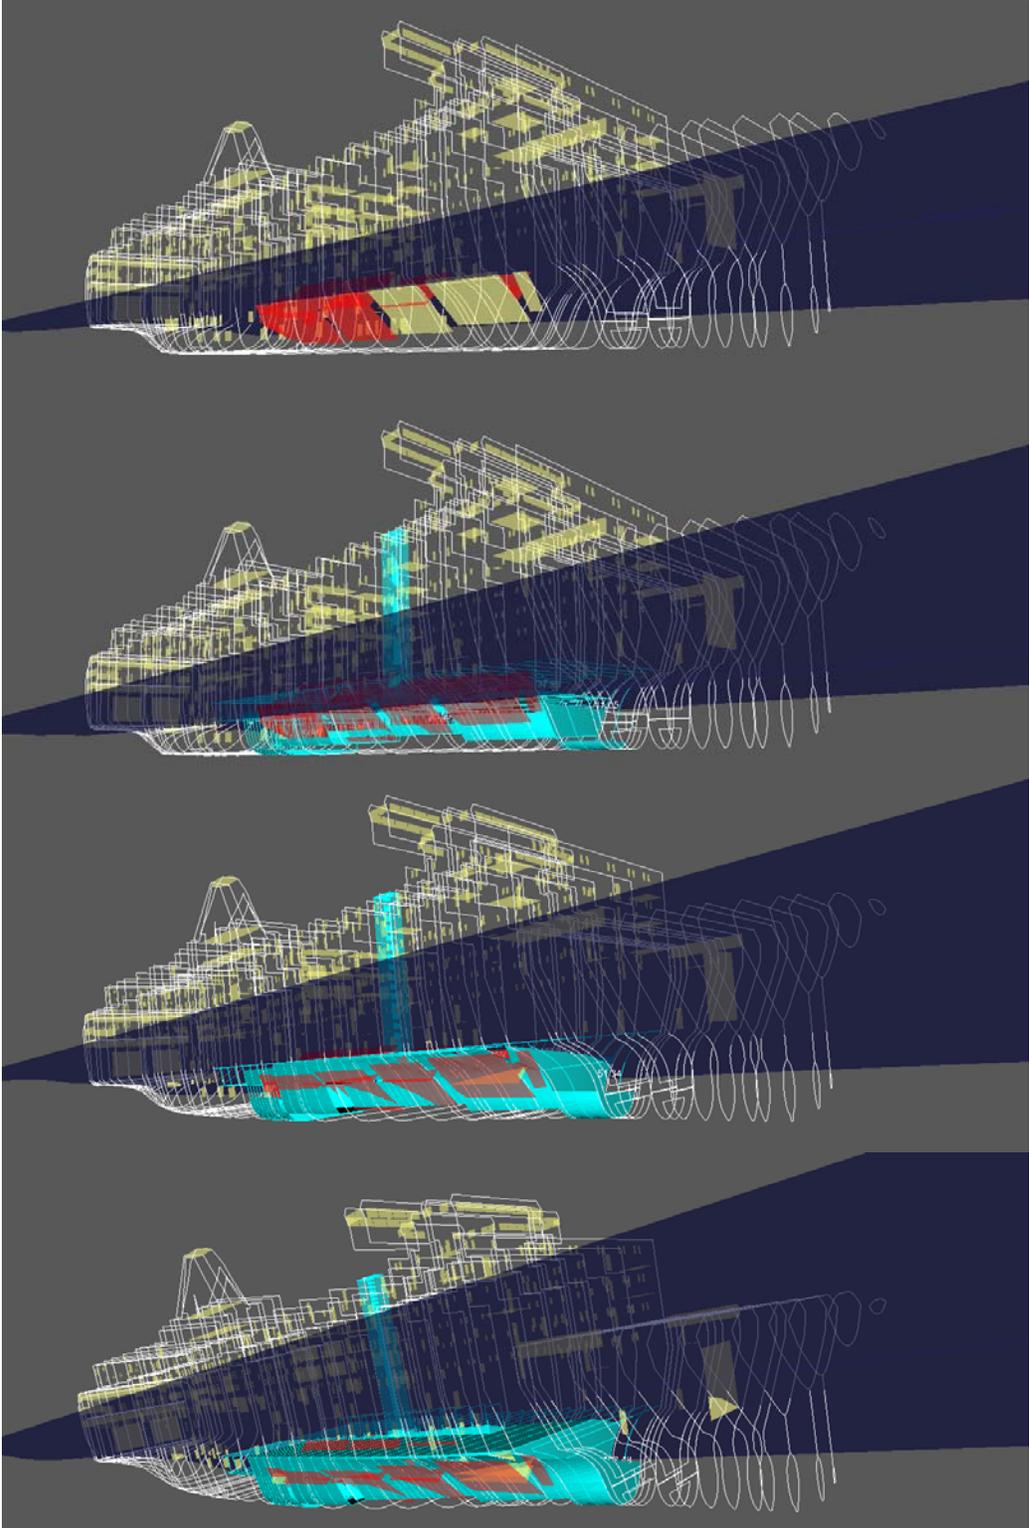
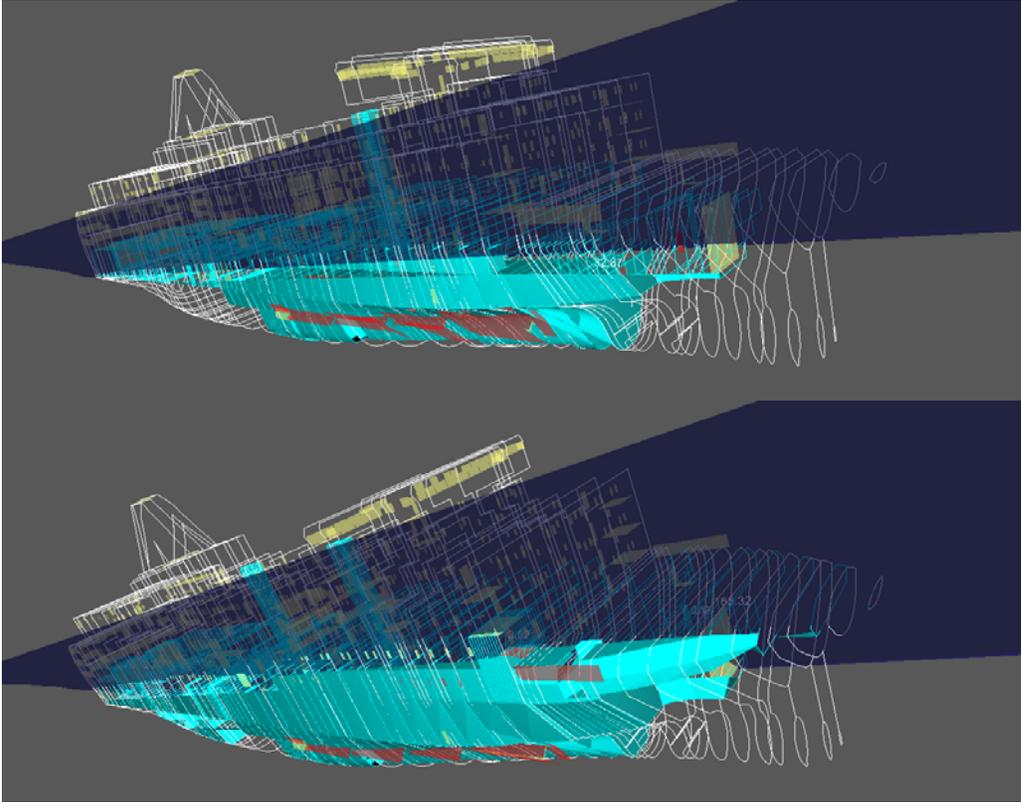
Fig. 32 shows a sample snapshot of the PROTEUS3 simulation of flooding of spaces on Deck 0/1 forward.

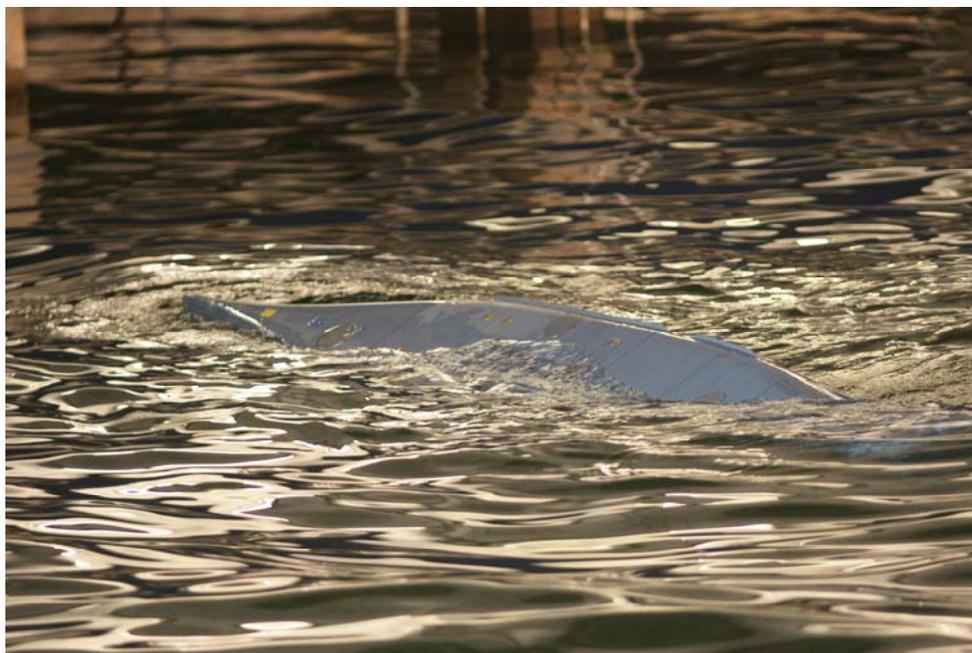
Fig. 34. Ship model in heel angle 150-160 degrees. Due to scale effects in air compressibility air was ejected from a calibrated valve at the stern of the model.

Several tests under the same conditions were carried out to assure the repeatability of the tests. In the final phase of the foundering, when the model had reach a heel angle of 150-160 degrees the aft valve was opened less then one minute to compensate for air compressibility.

Figs. 34 to 36 show the final phase of the foundering. The ship model sank with stern first and rested with the aft part of the superstructure on the bottom of the basin. The forward part of the ship model with the bulb was now still above the surface. In this position the forward valve was opened a few seconds and now also the bow sank. This means that the amount of air ejected from the model was in the order of 8 litres.

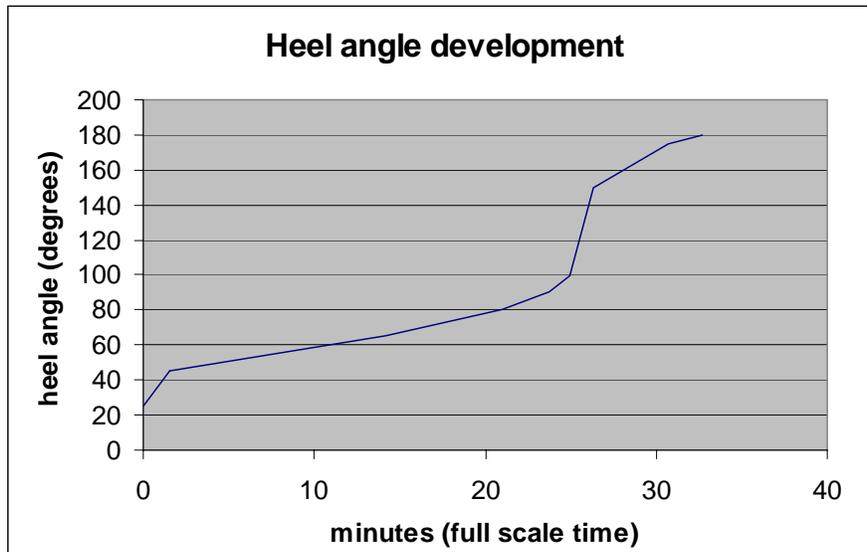
In Fig. 37 the heel angle development during the foundering test is shown.
